The Steel Company of Canada

#### Hamilton Works Community Liaison Committee Meeting Q2 2021

July 2021

## **#1 Baywater Intake – Recent Maintenance Dredging**

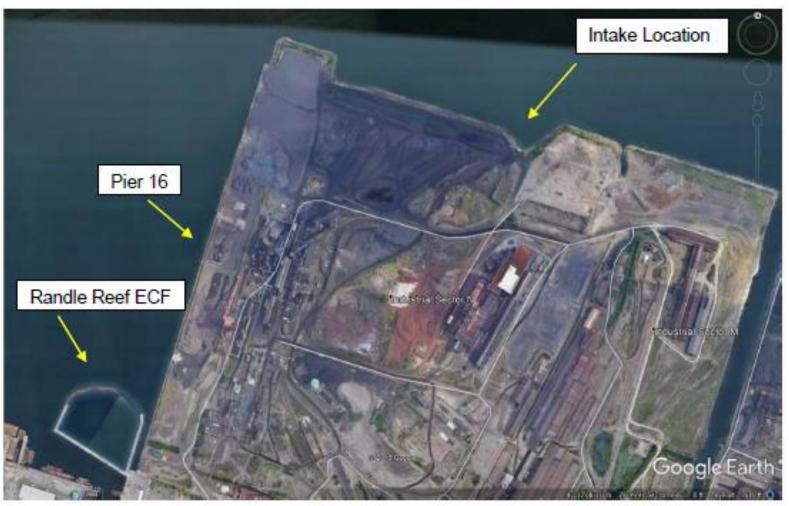
### **Aerial View**

- Stelco's #1 Baywater intake is located at the north side of the plant. Water from Hamilton Harbour is used for dust control on our coalfield plant roadways
- It was observed that the water flow was reduced as the water tankers were being filled
- Inspection showed that silt and sediment had built up around the pipe

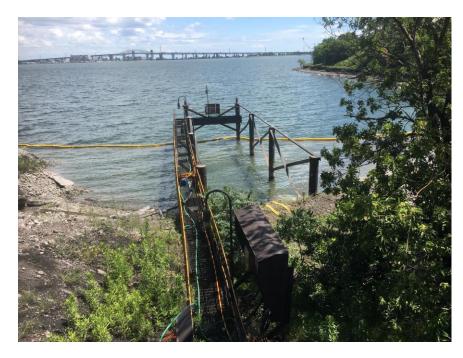
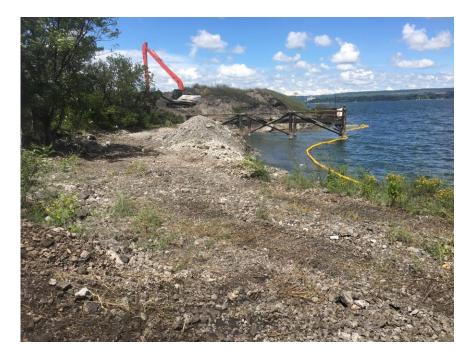
The sediment on either side of the pipe was dredged with a long reach excavator. The excavated silt and sediment was placed on the bank to dewater prior to disposal. Prior to dredging, a silt curtain was installed completely around the structure to contain any silt during the excavation work.
